# BC Abatement Services

Subject Property Address: 37 Bracken Park Way, Squamish

## HMS Pre-Demo Scope of Work & Recommendations

| Project Scope |
|---|
| Mobile home is being demolished. All materials will be affected. |

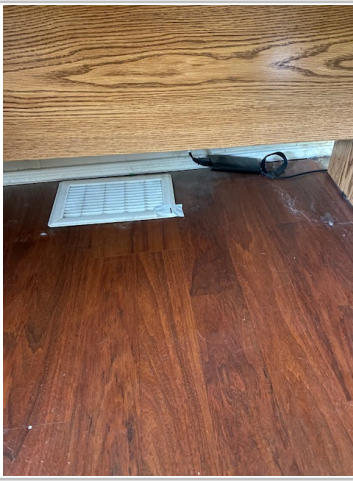
1. Living room floor, bottom layer. No asbestos detected.

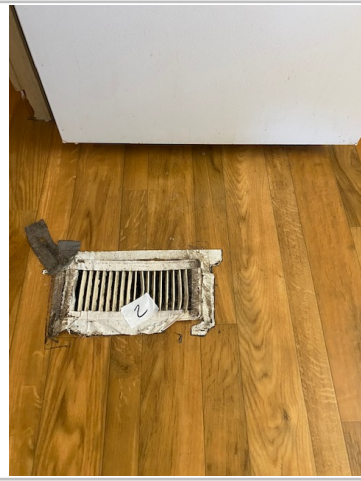
2. Kitchen floor, bottom layer. No asbestos detected.

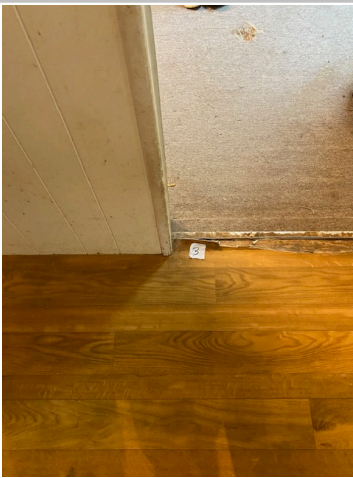
3. hallway floor, first layer. No asbestos detected.

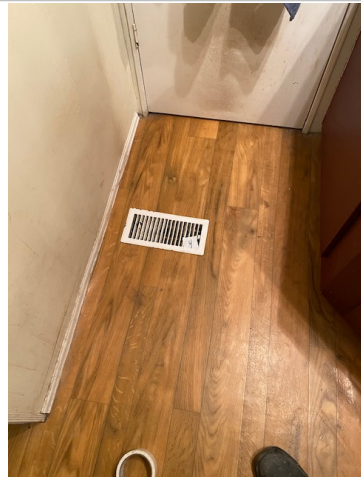
4. Bathroom floor, first layer. No asbestos detected.

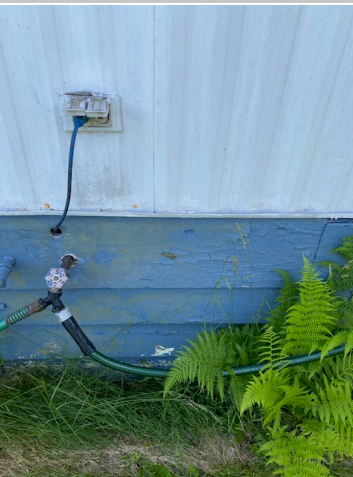
| Summary of Asbestos Containing Materials (ACM) | | |
|---|---|---|
| Exterior | Black mastic                      Good | 10 lf    chrysotile    8% |

5. Black mastic sealant around exterior power socket. Asbestos was detected.

**All confirmed and suspect asbestos containing materials (ACM) identified in table 2 and 3 must be removed and disposed of as asbestos by a hazardous materials contractor prior to demolition or disturbance as per Work safe BC regulation part 20.112.**

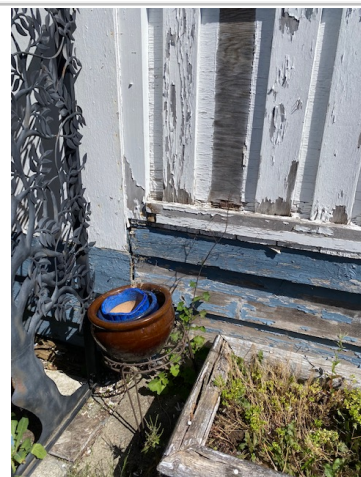
| Lead Summary Results | | | | | |
|---|---|---|---|---|---|
| L1 | Exterior siding | Blue pain multi layered | N/A | 8793 | Yes |
| L2 | Exterior siding | White pain multi layered | | 8560 | Yes |

Lead was detected on the exterior paint. Blue and white. All painted surfaces should be assumed to contain lead.

L1-2. Exterior blue and white paint. Lead containing.

| Lead Conclusions & Recommendations |
|---|
| <p>-When performing hand demolition work to protect workers from potential airborne lead dust. Respirators equipped with P100 filters should be worn and dust control with the use of HEPA negative air filtration may be necessary. Workers should wash their hands with soap and water prior to eating or smoking.</p> <p>-In the event that the surfaces to which lead-based paint or coating has been applied are disturbed by sanding, grinding, burning etc., the paint must be removed prior to the actions.</p> <p>-The removal of lead paint must be performed in accordance with WorkSafe BC Occupational Health and Safety Regulations following the procedures outlined in the WorkSafeBC publication “Lead-Containing Paints and Coatings, Preventing Exposure in the Construction Industry”. Only workers with lead training should perform this task.</p> <p>Toxicity Characteristic Leaching Procedure (TCLP) testing was not performed as part of this survey. TCLP testing may be required for lead paint exceeding 600mg/kg to classify the materials as Special Waste or regular demolition waste.</p> |
